Restoration in the Truckee River Watershed

Beth Christman
Truckee River Watershed
Council

Davies Merrill Restoration

Lower End Site 5 Davies-Merrill Watershed Restoration Project

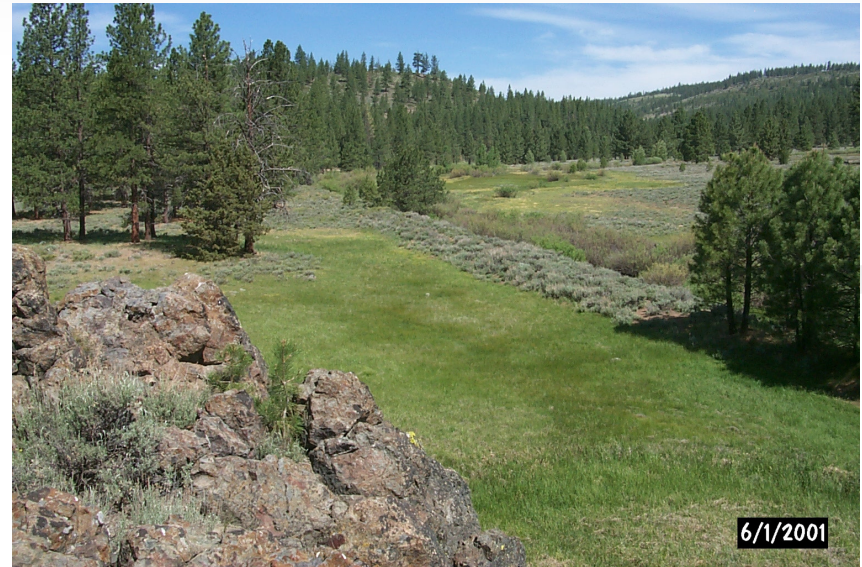
What's the problem?

- Historic railroad grades
- Stream diversion
- Floodplain restriction

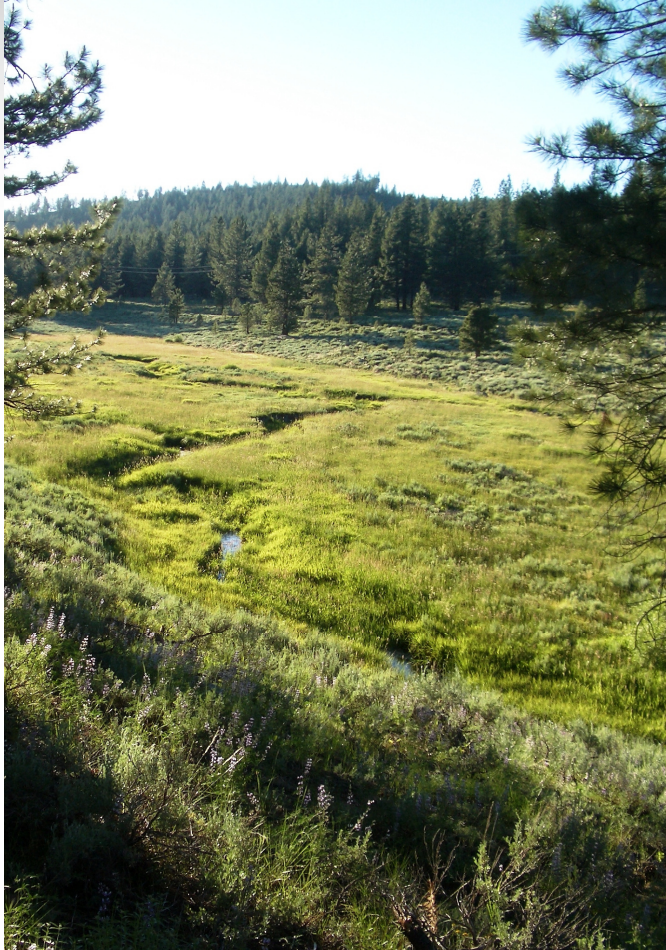
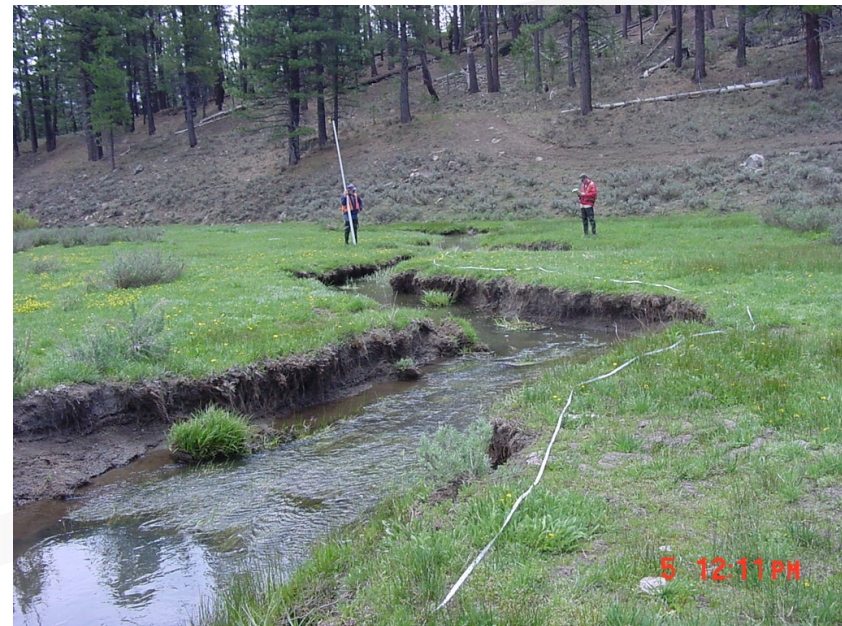
What's the problem?

- Incised channels
- Increased erosion
- Excessive sedimentation

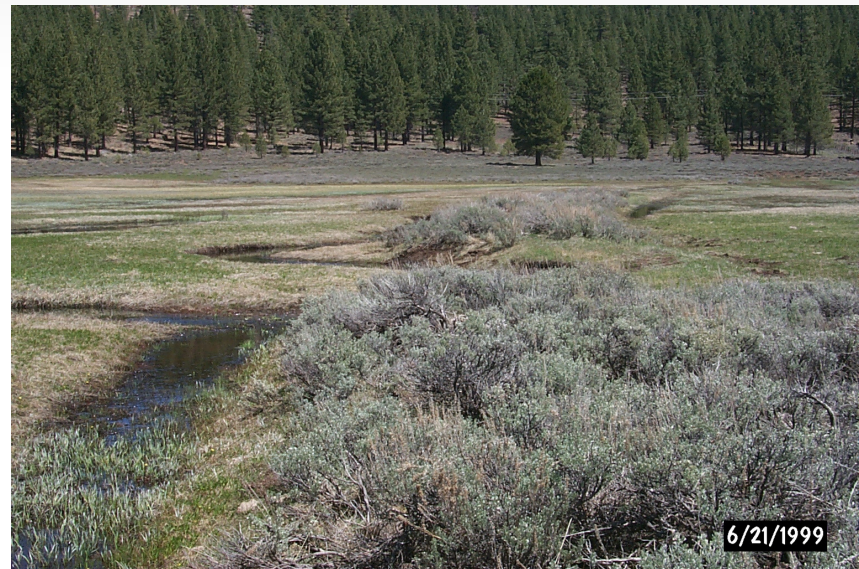
What can we do?

- Remove railroad grades
- Restore natural hydrologic pattern
- Restore floodplain area

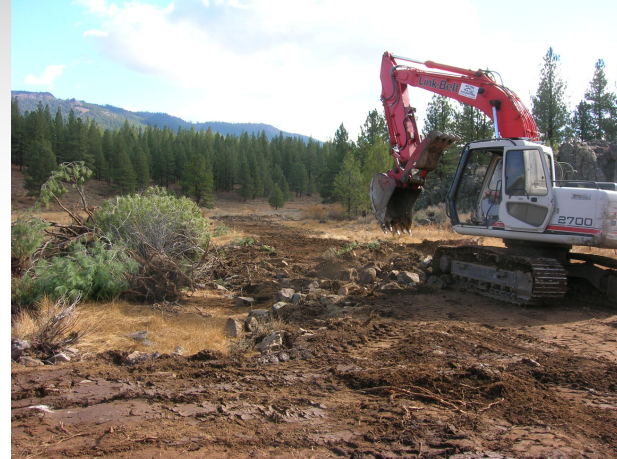
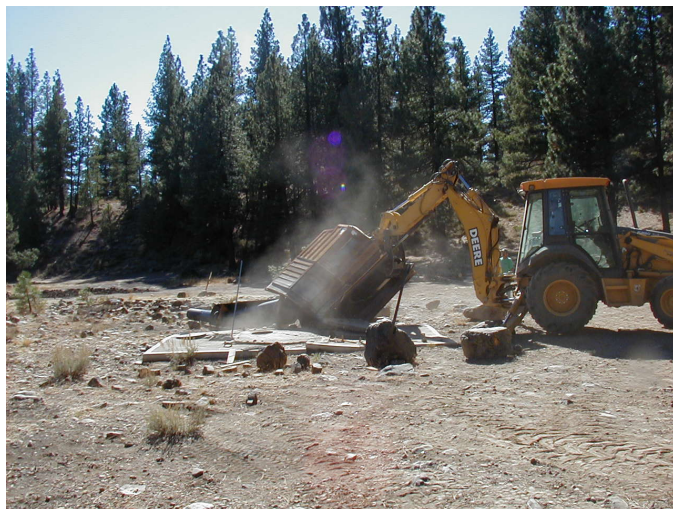
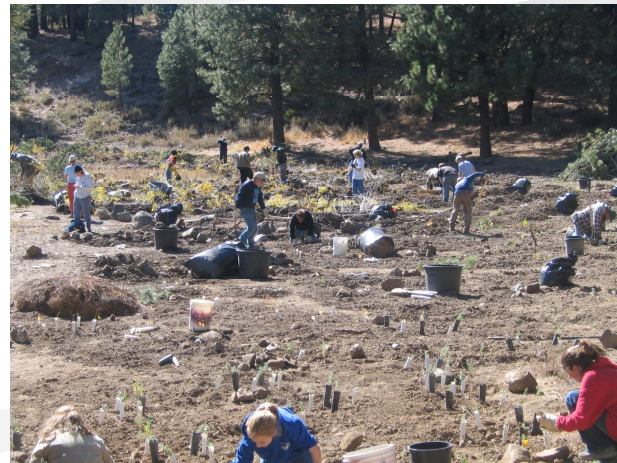
2005 work

- Removal of grade at site 6
- Plug and pond at Lower Site 5
- Re-vegetation work at Site 5

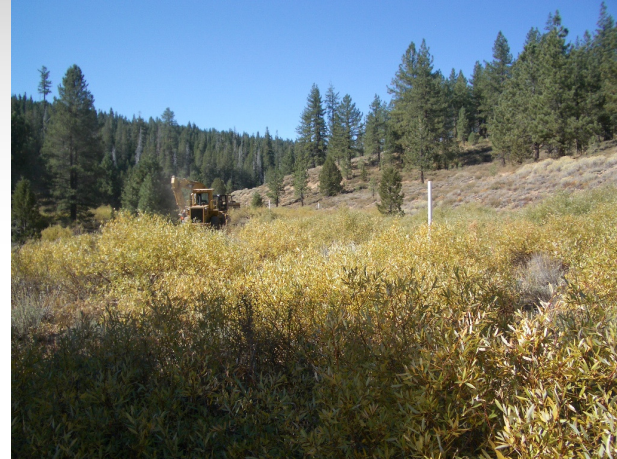
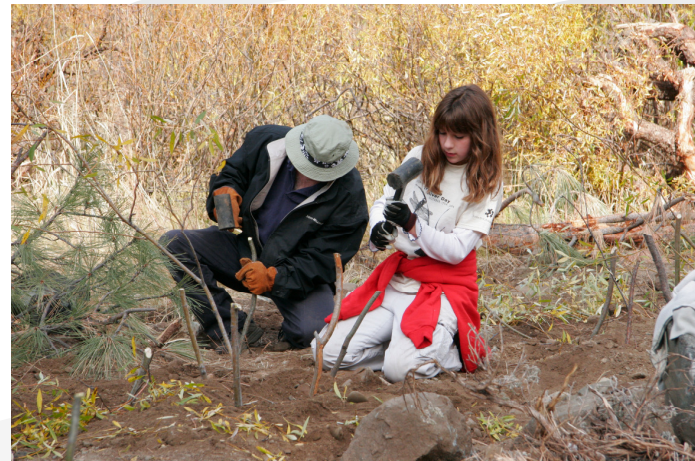
2006 work

- Plug and pond at sites 2 & 12
- Extensive volunteer re-vegetation effort
- Installed groundwater monitoring wells
- Began vegetation monitoring

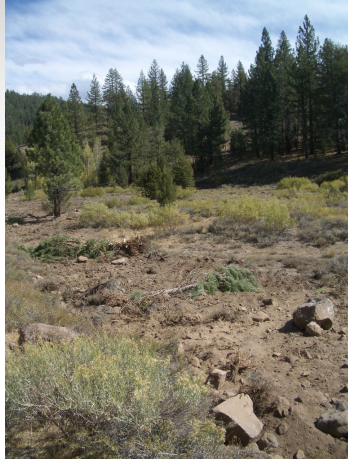
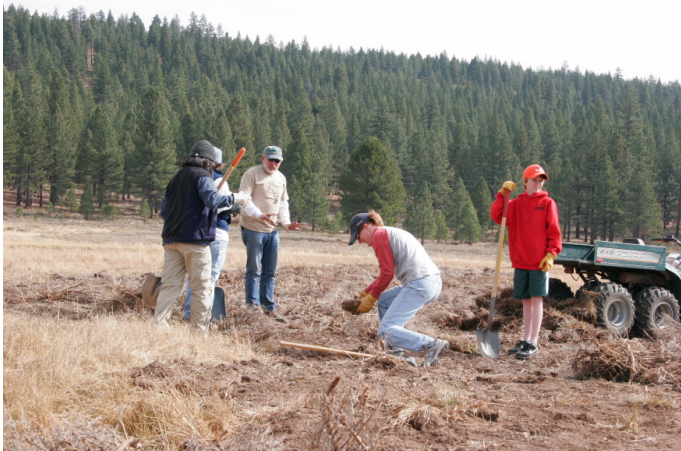
2007 work

- Completed site 2 & 12
- Plug and Pond site 3
- Remove old road site 4
- Continue monitoring

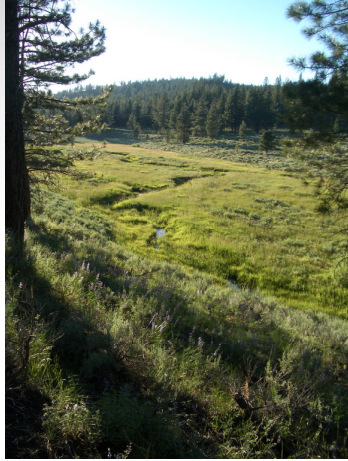
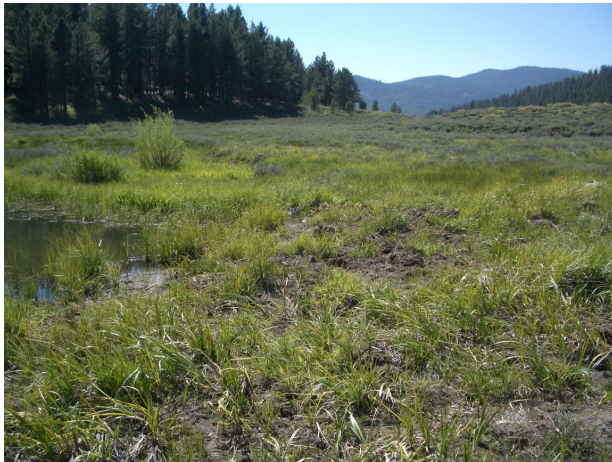
Sediment reduction

- Estimated annual reduction of 500 cy fine sediment from active erosion
- Undetermined amount from upper watershed

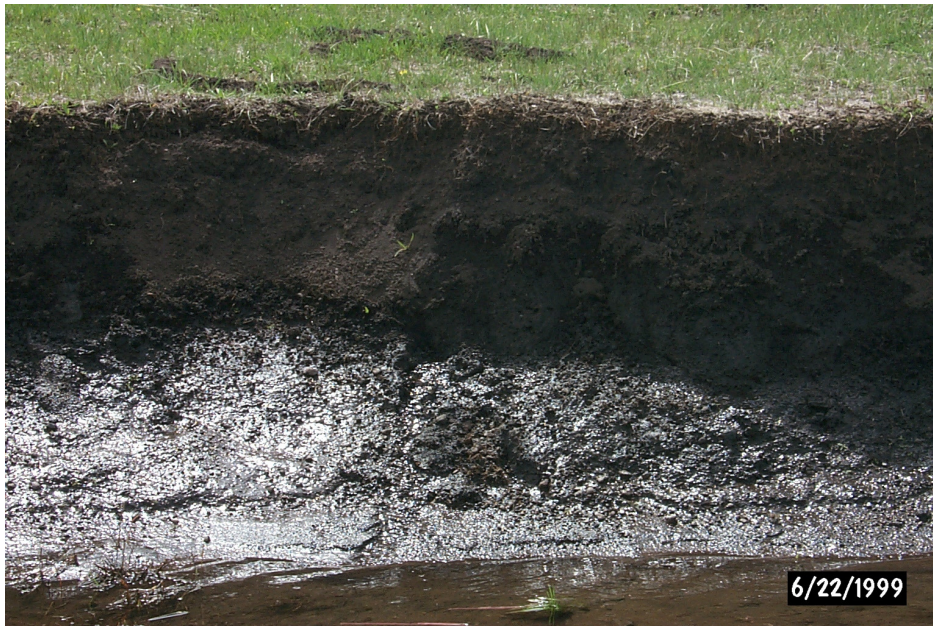
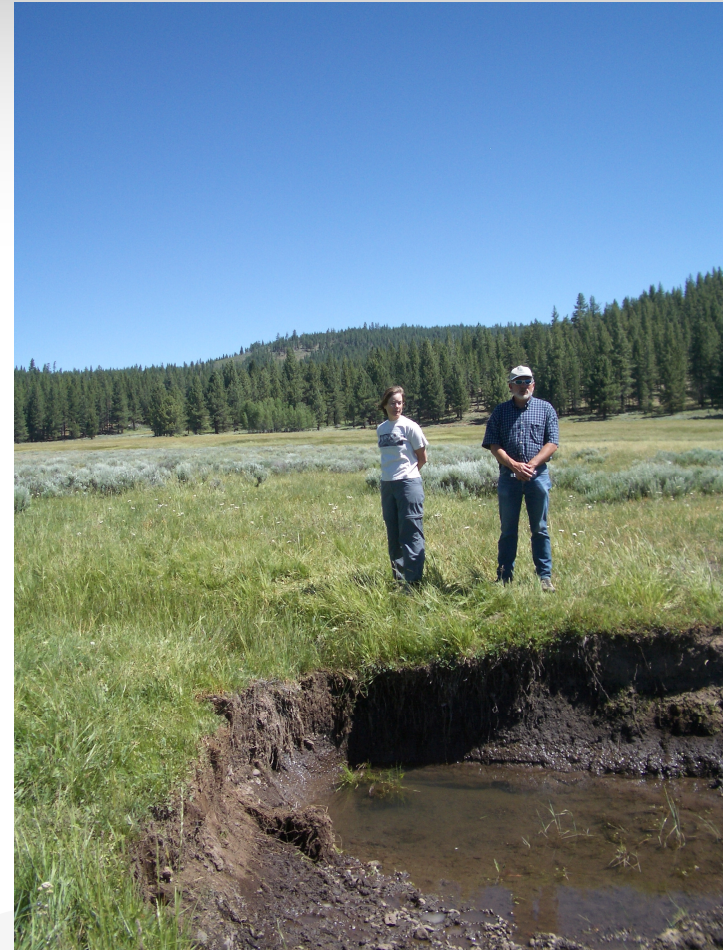
What's the problem?

- Active headcutting
- Further instability
- Groundwater loss

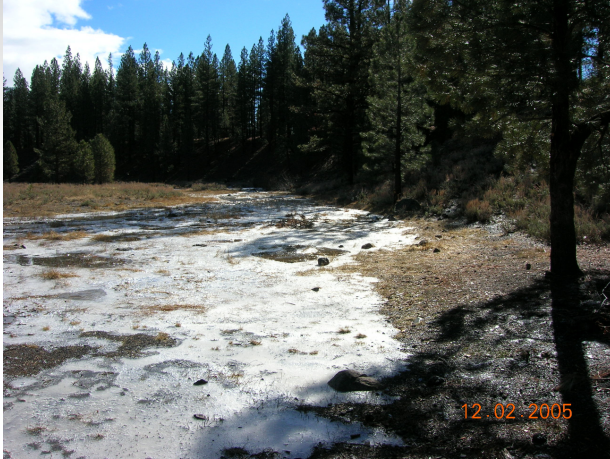
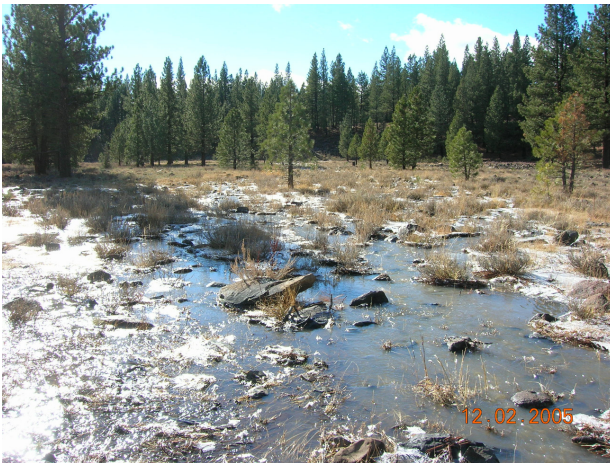
December 2005

- First storm
- Stream in remnant channel
- Plug #1 low
- Sandbags added

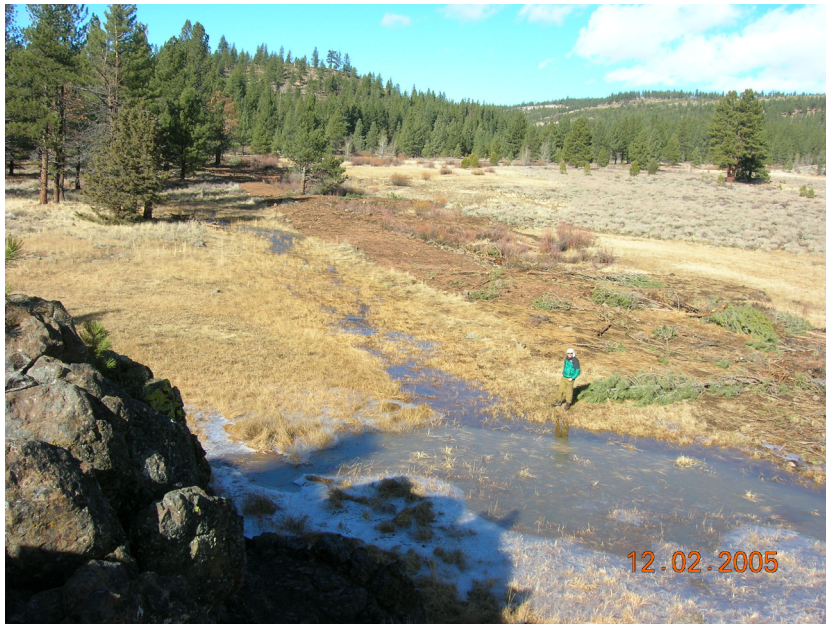
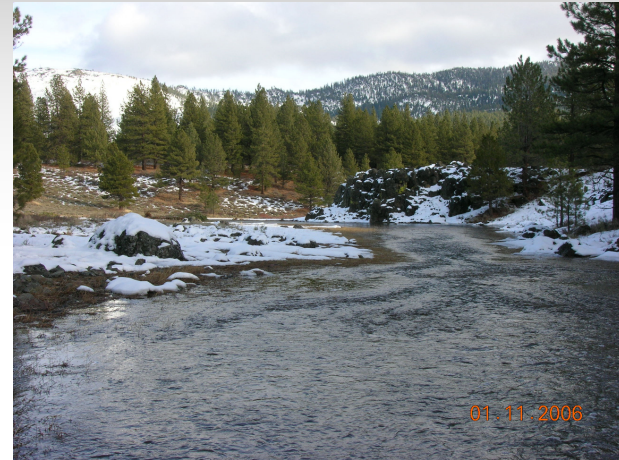
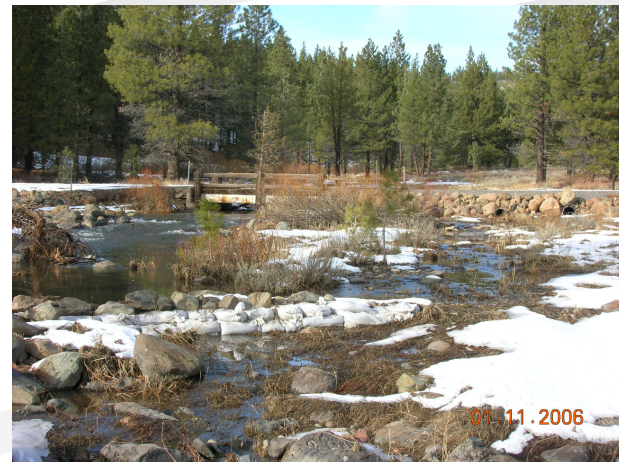
January 2006

- Heavy rain event
- November fix held
